Errata

**MSP430F4481 Microcontroller**

This document describes the known exceptions to the functional specifications (advisories).

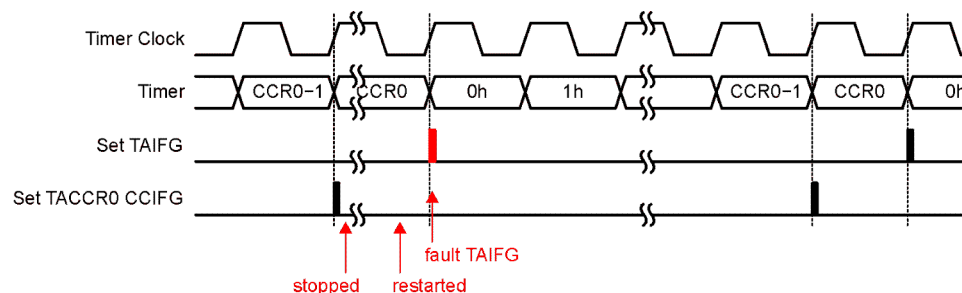
TAIFG Flag is erroneously set after Timer A restarts in Up Mode

In Up Mode, the TAIFG flag should only be set when the timer counts from TACCR0 to zero. However, if the Timer A is stopped at TAR = TACCR0, then cleared (TAR=0) by setting the TACLR bit, and finally restarted in Up Mode, the next rising edge of the TACLK will erroneously set the TAIFG flag.

**Workaround** None.

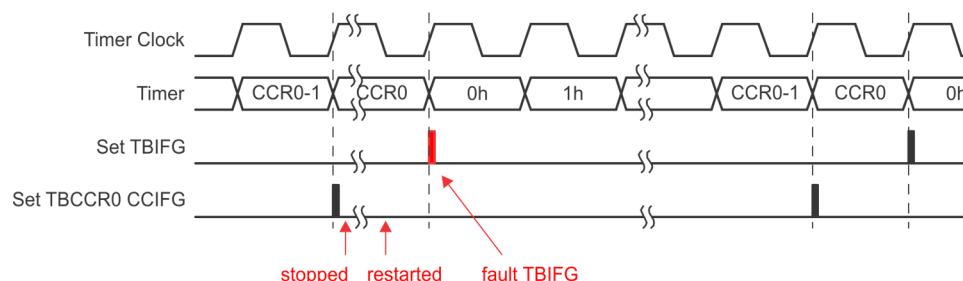
**Function** TBIFG Flag is erroneously set after Timer B restarts in Up Mode

**Description** In Up Mode, the TBIFG flag should only be set when the timer resets from TBCCR0 to zero. However, if the Timer B is stopped at TBR = TBCCR0, then cleared (TBR=0) by setting the TBCLR bit, and finally restarted in Up Mode, the next rising edge of the TBCLK will erroneously set the TBIFG flag.

**Workaround** None.
