Errata

**MSP430F5525 Microcontroller**

This document describes the known exceptions to the functional specifications (advisories).

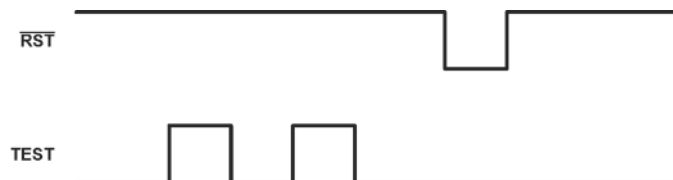
Note: This toggling of TEST pins is not subject to timing constraints. The appropriate level transitions on TEST pin, followed by a RST pulse after 50us, are sufficient to trigger an exit from BSL mode.

- Toggle the TEST pin twice when nRST is high and after 50us pull nRST low.
